# “Don't Cure, Prevent!”

PaSea Circular 08/2017

## SUBJECT: 'Main Deck Maintenance work - Checked✔!'

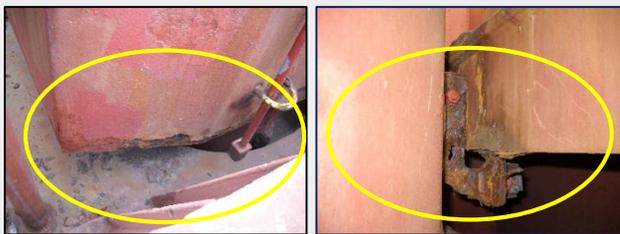
### 1. General Condition

*Due to weather exposure, frequent checks of the deck and cargo equipment should be performed regarding their general condition.*

*Rusty parts or indications of corrosion should be treated, as necessary.*

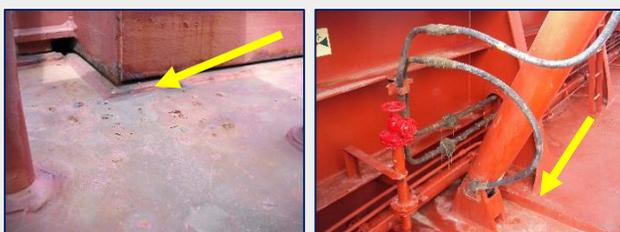
### 2. Steel Plates

*Do not overlook the fact that the steel plating and supporting structure condition should be checked to ensure that is still sound. Remember that properly painted plating may contribute to the overall good appearance of the main deck, but it is not always an evidence that panels are in good shape.*
