## E/R FUNNEL FIRE DAMPERS UNABLE TO FULLY CLOSE STRONG FIRE BOUNDARIES BEGIN WITH CLOSED DAMPERS.

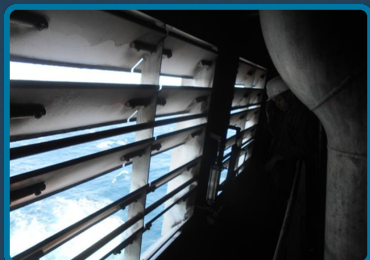
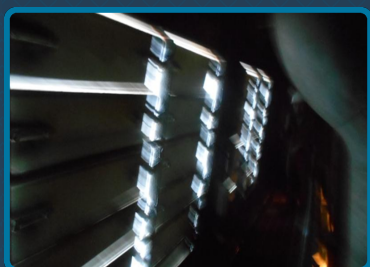
During an onboard pre-vetting inspection, the PAS Auditor observed that the engine room (E/R) funnel dampers did not close fully from the local control position. A visible gap remained between the damper flaps, allowing daylight and outside air through even when the handle indicated fully closed. The remote closing arrangement was also tested and found to produce the same incomplete closure. Had a fire occurred, the dampers would not have isolated the space from the external air supply, undermining any fixed fire-extinguishing system used to fight it.

**Lack of preventive maintenance:** the damper flap linkage had become slack over time due to wear of the connecting rods and pivot points, so the closing mechanism reached the end of its travel before the blades were fully seated.

**Inadequate inspection and testing system:** existing inspection and testing practices failed to find this defect.

**Insufficient senior officer supervision:** neither the Master nor the senior engineers had personally verified full damper closure during drills or rounds, relying instead on the routine reporting of ratings that the mechanism was "operated and closed", without ascertaining whether the inspection and testing had been effectively carried out.

- Include a planned maintenance task for fire dampers, flaps and closures that requires physical confirmation of full closure, checking for corrosion, wastage, hardened gaskets and seized components, not just handle position.

- During fire drills, physically verify that dampers are fully seated with no gaps, testing both local and remote or hydraulic closing arrangements, and confirm that "Open" and "Closed" positions remain clearly marked.

- Inspect and lubricate damper linkages, hinges, securing dogs and closing wires regularly, renewing worn or seized components promptly to prevent loss of full closure.

- Require superintendents to verify the condition, marking and full closure of fire dampers, skylights and ventilation flaps during onboard visits.
- Circulate this case across the fleet and reinforce, through onboard training, that a damper which does not close fully is a non-compliance that can expose the crew and vessel to an uncontrolled fire, with the potential to escalate into a catastrophic event.
