Tip of the Week – Preventing Risk

CASE STUDY #18 PaSea H.EL.M.E.T. Marine Risk Assessment

RISK ELEMENT: Permit to Work System & Engine Room's Safe Conditions

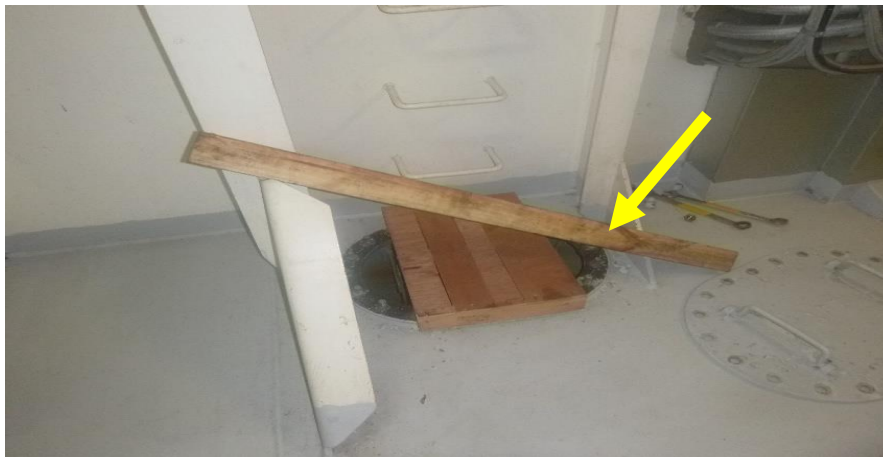
MRA FINDING: A manhole was found in the Engine Room covered with pieces of wood without an issued Enclosed Space Entry Permit

COMPANY SAFETY PROCEDURES WERE NOT FOLLOWED ON BOARD. THIS CAN PROVE VERY DANGEROUS LEADING TO CREW MEMBER INJURIES DURING/AFTER WORK.

AN ENCLOSED SPACE ENTRY PERMIT SHOULD HAVE BEEN ISSUED AND COMPANY PROCEDURES SHOULD HAVE BEEN FOLLOWED. IN ORDER TO AVOID INJURY, THE CREW SHOULD HAVE BEEN PROPERLY INFORMED ABOUT THE OPEN MANHOLE AND A WARNING NOTICE ALONG WITH A TIGER COLOR TAPE SHOULD HAVE BEEN PLACED TO SECURE THE AREA.
