Tip of the Week – Preventing Risk

CASE STUDY #37 PaSea H.EL.M.E.T. Marine Risk Assessment

RISK ELEMENT: Safe Mooring Arrangements

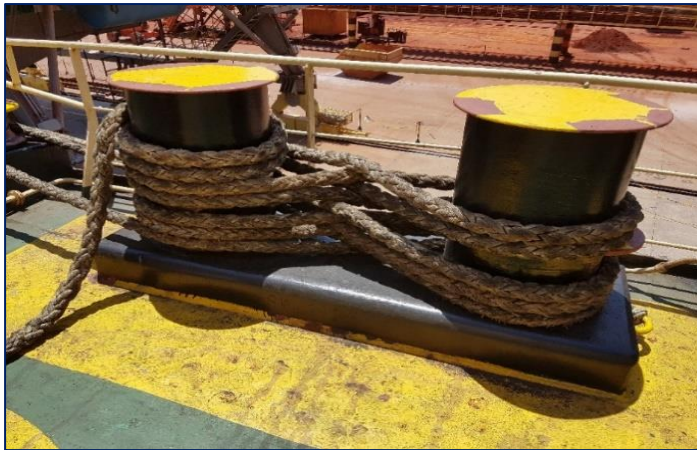
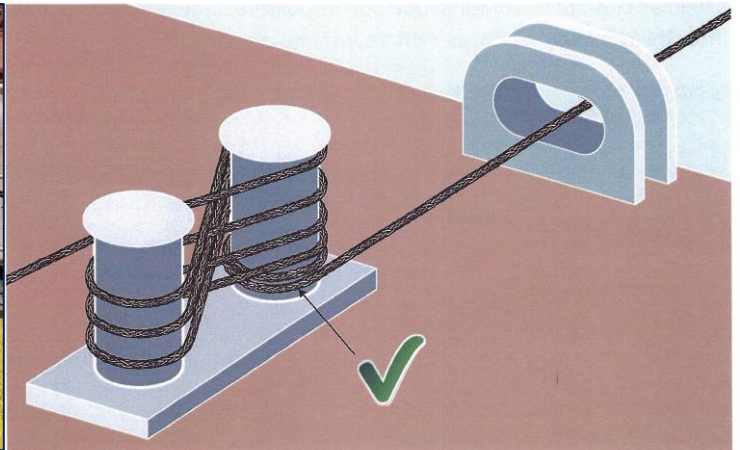
MRA FINDING: Mooring lines were not secured to double post mooring bitts

REF. MEG 4 – 7.3.2.2

WHEN THE CREW WERE ASKED ABOUT THIS ISSUE, THEY COULD NOT PROVIDE AN EXPLANATION AS TO WHY THEY SECURED THE MOORING LINES IMPROPERLY AND WERE NOT ABLE TO PROVIDE THE CORRECT WAY OF SECURING.

IT IS RECOMMENDED THAT WHEN SECURING MOORING LINES TO DOUBLE POST MOORING BITTS, TWO TURNS ARE PLACED AROUND THE 1ST POST BEFORE BEGINNING THE BELAY FIGURE OF EIGHTS. IF THE INITIAL STEP IS MISSED (i.e. TWO FULL TURNS OF THE MOORING LINE AROUND THE 1ST POST), A HIGHER STRESS IS INDUCED TO EACH POST, CREATING A TENDENCY FOR THE BITTS TO BE PULLED TOGETHER.
