Tip of the Week – Preventing Risk

CASE STUDY #42 PaSea H.EL.M.E.T. Marine Risk Assessment

RISK ELEMENT: Embarkation & Disembarkation

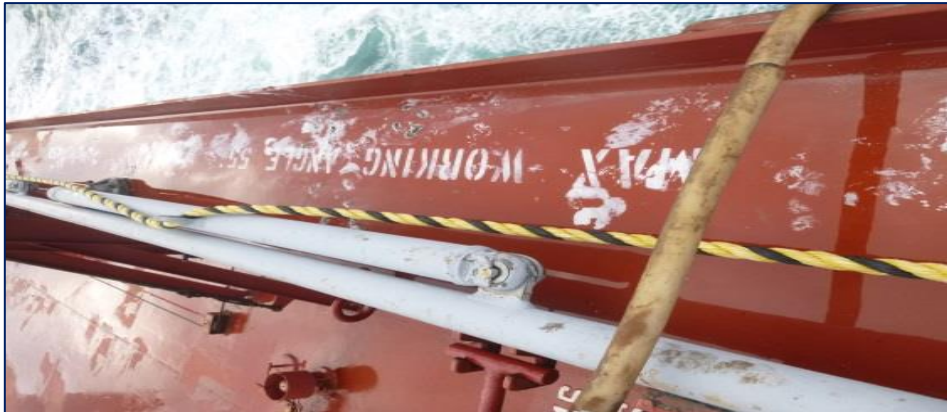
MRA FINDING: Absence of marking for minimum permitted design angles of inclination on both gangway ladders. All other information appropriately marked.

REF. VIQ 5.47 & MSC.1/Circ. 1331/3.5

EACH ACCOMMODATION LADDER AND GANGWAY SHOULD BE CLEARLY MARKED AT EACH END WITH A PLATE SHOWING THE RESTRICTIONS ON THE SAFE OPERATION AND LOADING, INCLUDING MAXIMUM & MINIMUM PERMITTED DESIGN ANGLES OF INCLINATION.

INSPECTION OF EMBARKATION ARRANGEMENTS SHOULD BE MORE DETAILED IN ORDER FOR SUCH OMISSIONS TO BE PREVENTED. ADDITIONALLY, THE OPERATOR SHOULD PROVIDE TO THE CREW MORE SPECIFIC AREAS OF INSPECTION INCLUDING THE CORRECT MARKING.
