FAILURE OF MOORING BOLLARD

INCIDENT: During a real-time cargo audit, the PAS Assessor reported that the vessel was secured to the pier’s bollards using her own mooring lines. During the night and while the discharging operation was still in process, excessive winds developed massive forces on the ship’s hull resulting in the bollard’s failure.

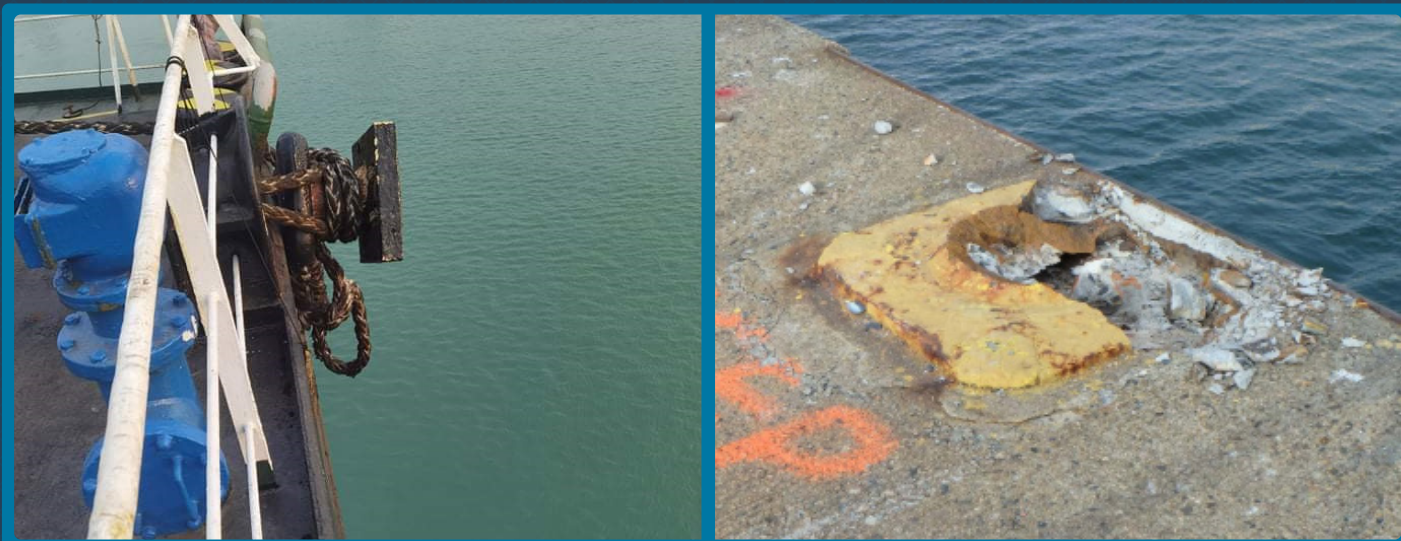
- The wind speed & direction indicator at the ship’s control room was switched off.
- Officers omitted to monitor weather conditions during vessel’s stay at port.
- Deck Officers on watch did not inform Cargo Control Room regarding weather deterioration.
- Shore personnel omitted to check the bollards condition.

The ship lost secured mooring integrity from astern and started swinging inside the port. This could result to a collision with other nearby vessels.

- OOW informed the Harbor Master.
- The stand-by Port’s tugboats for emergency cases, assisted the vessel to return back to the pier.

- When alongside, inspect the mooring lines for signs of excessive tension, especially during discharging operation, where excessive angles are developed.

- Monitor weather forecasts and be prepared for emergency unmooring in cases of gale warnings.
- Never heave up a line when no one is monitoring the other end side.

- Select a mooring pattern, where the mooring lines are distributed equally amongst all available mooring bollards, so as the generated forces are split evenly.
