Tip of the Week – Preventing Risk

CASE STUDY #16 PaSea H.EL.M.E.T. Marine Risk Assessment

RISK ELEMENT: Human Element / BBS – Safe Mooring Arrangements

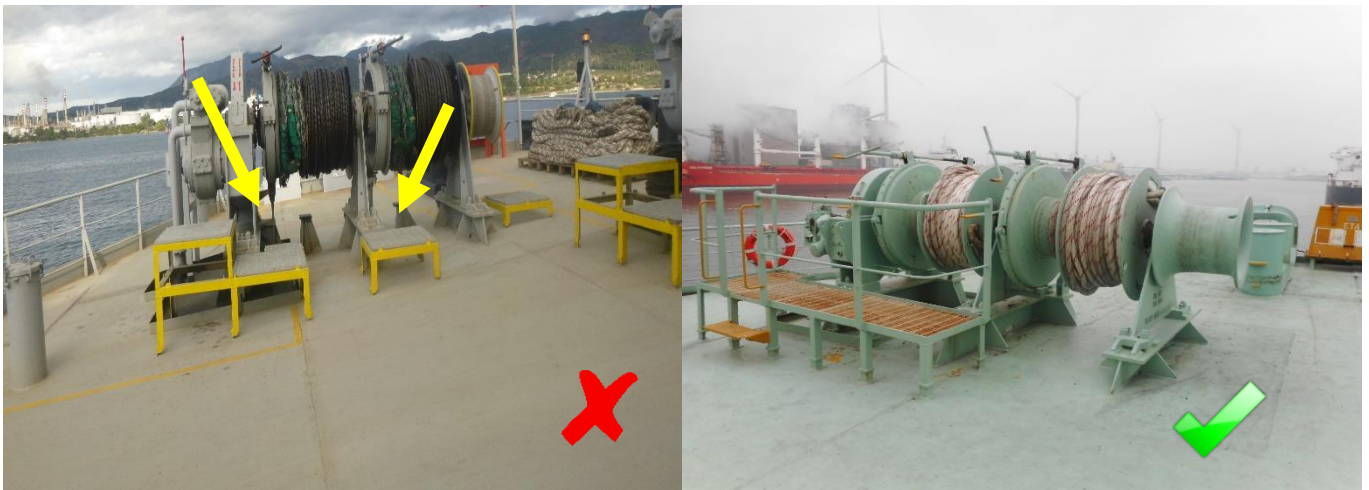
MRA FINDING: Protective rails were not fitted on the mooring winches (winch operator's position)

REF. SOLAS II-1/3-8, VIQ 9.8

WITH THE ABSENCE OF PROTECTIVE RAILS, THE WINCH OPERATOR MAY ACCIDENTLY FALL DURING A MOORING OPERATION ESPECIALLY IF THIS IS CARRIED OUT AT NIGHT.

IF PROTECTIVE RAILS ARE ABSENT OR IN BAD CONDITION, IT IS SUGGESTED THAT RAILS ARE FITTED ON ALL MOORING WINCHES AT THE NEXT DRYDOCK IN ORDER TO ENSURE CREW SAFETY DURING MOORING OPERATIONS.
