CASE STUDY #26 PaSea H.EL.M.E.T. Marine Risk Assessment

RISK ELEMENT: Steering & Emergency Steering

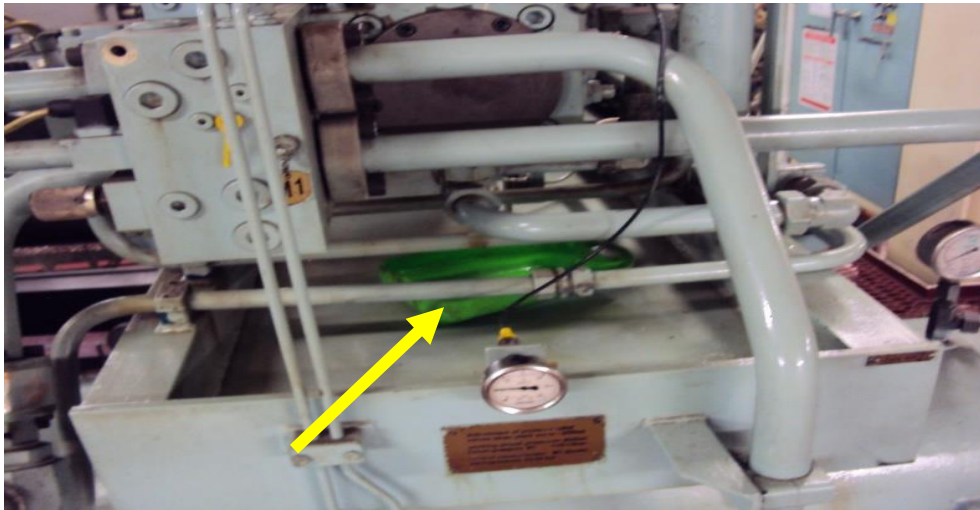
MRA FINDING: A plastic container was found under the steering gear's pipes indicating a leakage. Moreover, it was evidenced that the Company was notified about this leakage.

REF. SOLAS V/26

LEAKAGE FROM THE STEERING GEAR CAN LEAD TO MALFUNCTION OF THE SYSTEM COMPROMISING NAVIGATIONAL SAFETY. THE PLASTIC CONTAINER FOUND UNDER THE PIPES AND THE FACT THAT THE COMPANY WAS NOT NOTIFIED, INDICATES THAT THE CREW WAS NOT AWARE OF THE SERIOUSNESS OF THE SITUATION.

INSPECTION & MAINTENANCE OF THE STEERING GEAR SHOULD BE DONE AT REGULAR INTERVALS AND DEFECTS REPORTED TO THE COMPANY. REGULAR CREW TRAINING AND FAMILIARIZATION WITH SUCH SITUATIONS IS A MUST.
