**CASE STUDY #28** PaSea H.EL.M.E.T. Marine Risk Assessment

**RISK ELEMENT:** Deck Condition

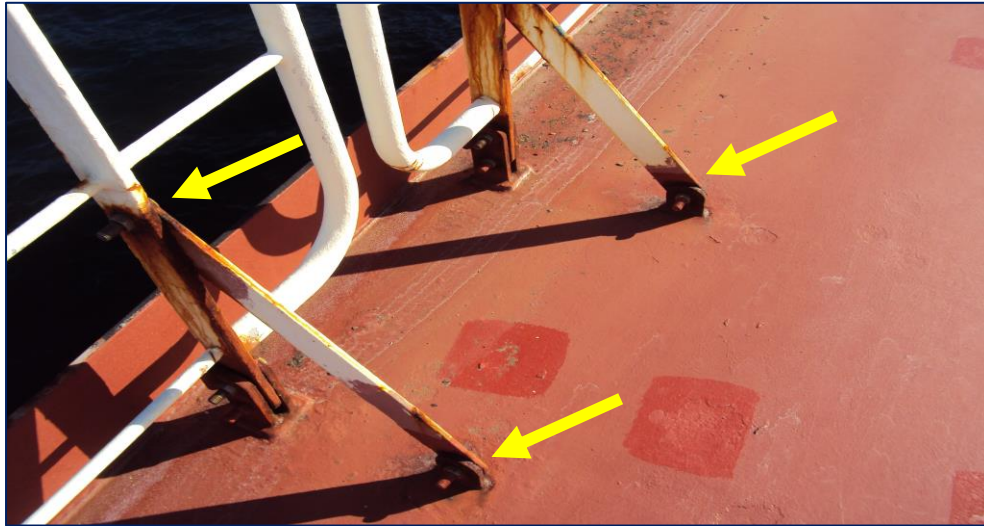
**MRA FINDING:** A number of the bolts on the Helicopter area's collapsible side rails were observed to be too tight for quick loosening

THE CONDITION OF THE FALLING RAILS AFFECTS POTENTIAL HELICOPTER OPERATION THAT MAY BE CARRIED OUT ONBOARD. THE QUICK DISMANTLING OF COLLAPSIBLE RAILS IS VITAL IN CASE OF AN EMERGENCY LANDING OF A HELICOPTER.

INSPECTION AND MAINTENANCE AT REGULAR TIME INTERVALS AS PER COMPANY'S PMS SHOULD BE DONE IN ORDER TO ENSURE PROPER DECK CONDITION.
