## Tip of the Week – Preventing Risk

**CASE STUDY #44** PaSea H.EL.M.E.T. Marine Risk Assessment

**RISK ELEMENT:** Ship Security Plans & Procedures

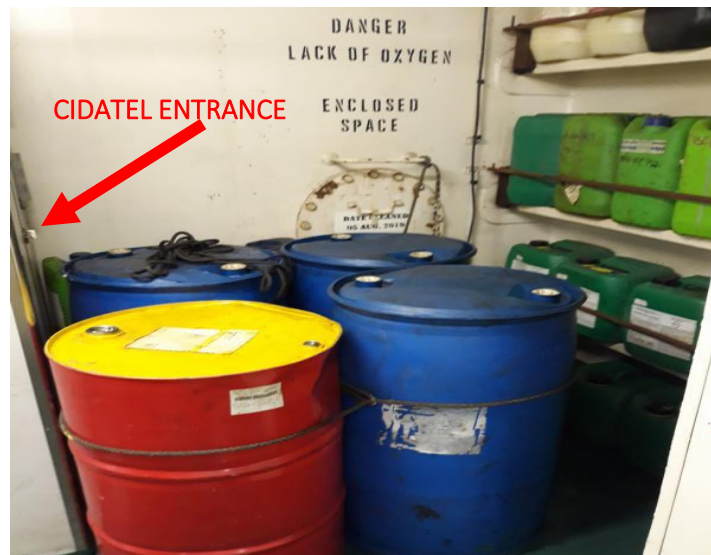
**MRA FINDING:** The Citadel's entrance was found blocked by barrels and there was no proof that the equipment inside the citadel was inspected by the crew.

**ALL CREW WITH THE EXCEPTION OF THOSE REQUIRED ON THE BRIDGE AND IN THE ENGINE ROOM, ARE REQUIRED TO MOVE TO THE SAFE MUSTER POINT / CITADEL WHEN CERTAIN CIRCUMSTANCES CALL FOR IT. THE CITADEL'S ENTRANCE MUST AT ALL TIMES BE UNOBSTRUCTED AND THE CREW NEEDS TO BE AWARE OF THE CONDITION OF THE ALL THE EQUIPMENT IN THE CITADEL.**

**CREW ALERTNESS REGARDING THE SHIP'S SECURITY PROCEDURES AND REQUIREMENTS MUST ALWAYS BE KEPT HIGH.**
