## Tip of the Week – Preventing Risk

**CASE STUDY #1:** PaSea H.EL.M.E.T. Marine Risk Assessment

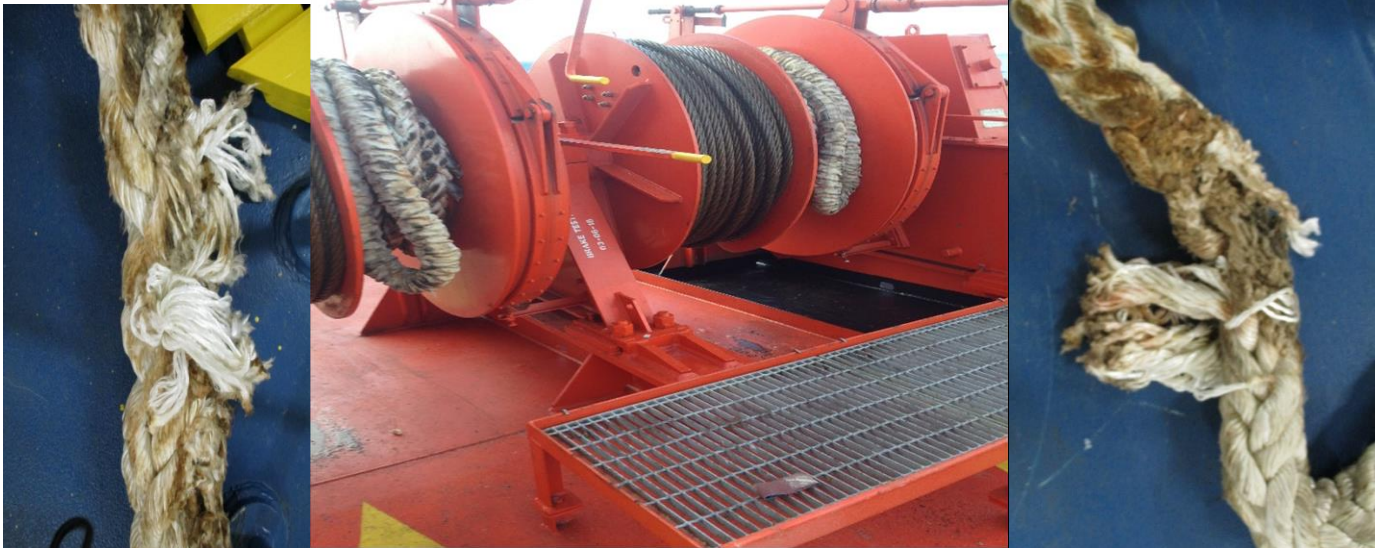
**RISK ELEMENT:** Mooring Tail

**MRA FINDING:** 20 mooring tails on service for more than 30 months without any evidence of regular checking

**AS PER CP 25-PARA 3.9, MOORING TAILS SHOULD BE REPLACED  
MAX EVERY 18 MONTH INTERVALS**

This period may be much less for a vessel engaged in lightening.  
Life span of a tail may be greater than 18 months, depending on the use and  
therefore need to be carefully checked after each use.
