## Tip of the Week – Preventing Risk

**CASE STUDY #10** PaSea H.EL.M.E.T. Marine Risk Assessment

**RISK ELEMENT:** Cargo & Bunker Sample Management

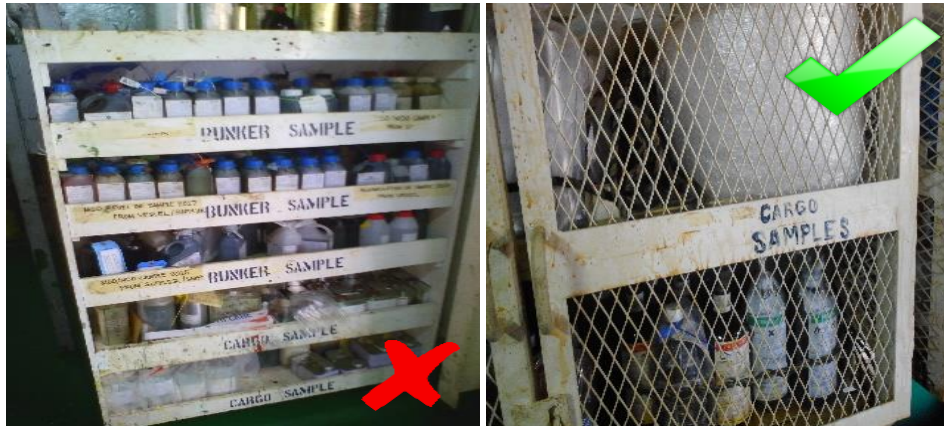
**MRA FINDING:** Cargo and bunker samples were stored in open shelves in the paint store instead of a lockable cabinet. Moreover, the shelves were made out of wood.

Despite the fact that the paint store was protected with a fixed fire-fighting system, the danger of fire was present due to the improper storage of the cargo & bunker samples, which were not securely stowed and the shelves were made of flammable material.

**IT IS SUGGESTED THAT THE STORAGE AND LOCATION OF CARGO & BUNKER SAMPLES IS CHECKED IN ORDER TO ENSURE THAT SAMPLES ARE SECURELY STOWED IN APPROVED TYPE LOCKERS**
