Tip of the Week – Preventing Risk

CASE STUDY #12 PaSea H.EL.M.E.T. Marine Risk Assessment

RISK ELEMENT: Cargo Lines & Inert Gas Lines

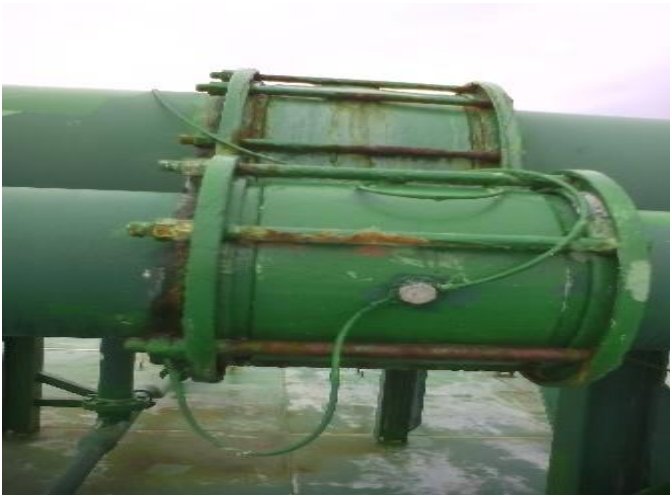
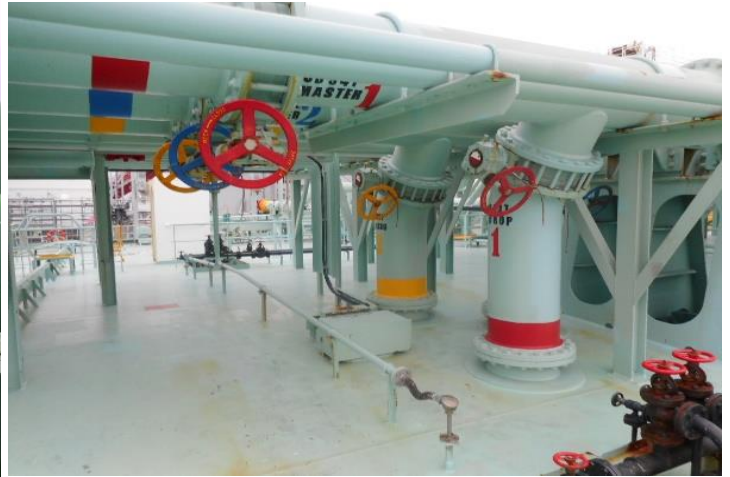
MRA FINDING: The majority of the Cargo line expansion joints on deck were found to be completely dry.

Non lubrication of the line expansion joints can cause serious damage to the protection rubber due to contraction and expansion resulting in oil pollution.

IT IS SUGGESTED THAT THE EXPANSION JOINTS ARE LUBRICATED WITH TALLOW OR SPECIAL GREASE. USE OF COMMON GREASE COULD DESTROY THE PROTECTION RUBBER. PROPER LUBRICATION OF EXPANSION JOINTS NEEDS TO BE CHECKED REGULARLY.
