CASE STUDY #36 PaSea H.EL.M.E.T. Marine Risk Assessment

RISK ELEMENT: Steering & Emergency Steering

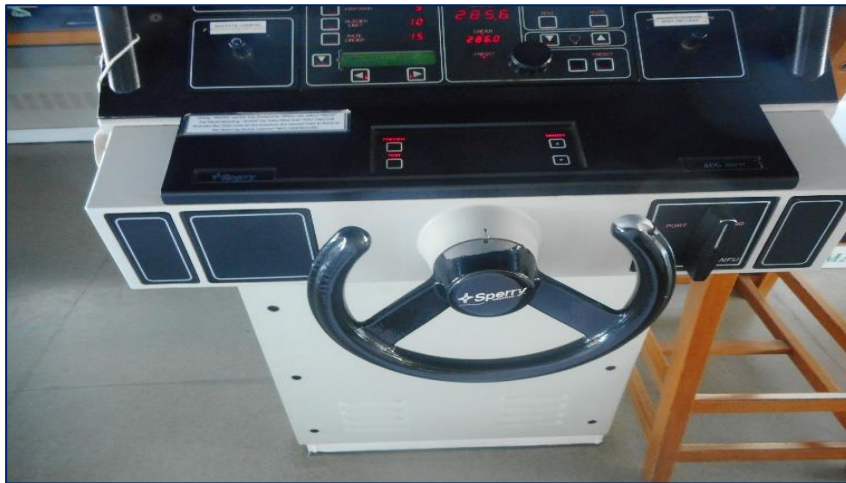
MRA FINDING: Auto pilot was not keeping the desired course and as a result the vessel was on manual steering for the most part of the journey.

**THE PROBLEM WAS REPORTED BY THE MASTER & OFFICERS TO THE COMPANY
VERBALLY...OVER THE PHONE.**

**THIS IS CONSIDERED AS MALFUNCTION OF THE VESSEL'S STEERING SYSTEM.
A DEFECT REPORT SHOULD HAVE BEEN COMPLETED AND SENT TO THE COMPANY SO
THAT THE MALFUNCTION CAN BE RECTIFIED AT THE NEXT PORT OF CALL.**
