Tip of the Week – Preventing Risk

CASE STUDY #4: PaSea H.EL.M.E.T. Marine Risk Assessment

RISK ELEMENT: Fire Hoses

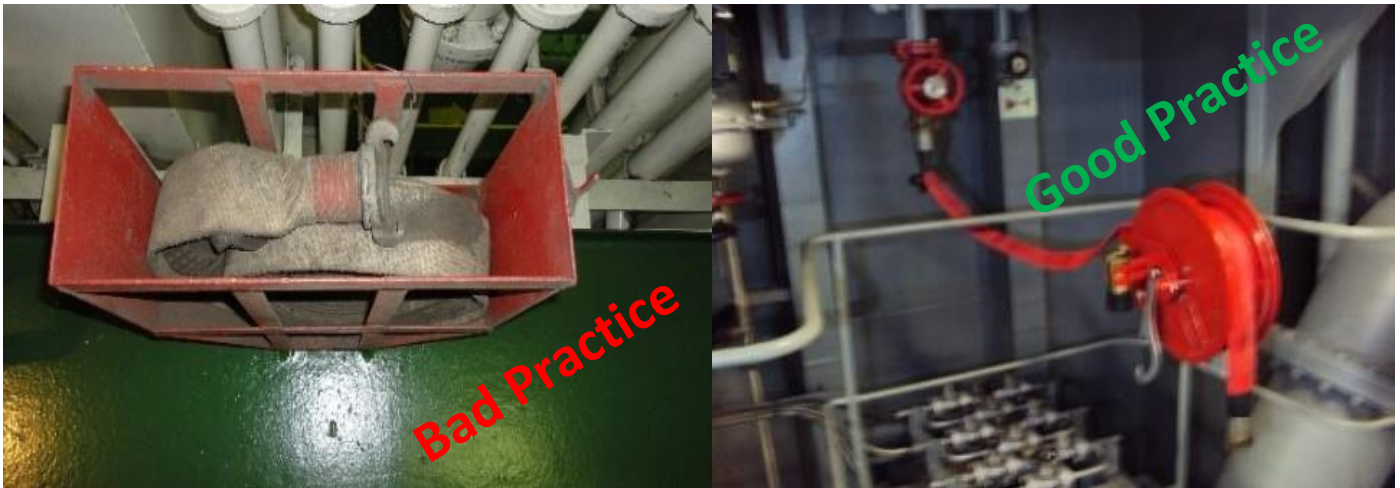
MRA FINDING: The fire hoses in E/R were not connected and ready for use - this was corrected during the Marine Risk Assessment

AS PER SOLAS PART C, REG 10, PARA 2.3.1.1

“HOSES SPECIFIED IN THIS CHAPTER AS FIRE HOSES SHALL, TOGETHER WITH NECESSARY FITTINGS AND TOOLS, BE KEPT READY FOR THE USE IN CONSPICUOUS POSITIONS NEAR THE WATER SERVICE HYDRANTS OR CONNECTIONS. ADDITIONALLY, IN INTERIOR LOCATIONS IN PASSENGER SHIPS CARRYING MORE THAN 36 PASSENGERS, FIRE HOSES SHALL BE CONNECTED TO THE HYDRANTS AT ALL TIMES”

Regardless of vessel type, having fire hoses readily & permanently connected on the water supply network can greatly assist the fire party by further stacking odds in their favor. This is especially true in machinery and interior spaces where accessibility and visibility could be seriously hampered in an event of fire.
