## Tip of the Week – Preventing Risk

**CASE STUDY #6:** PaSea H.EL.M.E.T. Marine Risk Assessment

**RISK ELEMENT:** Access Control & Restricted Areas

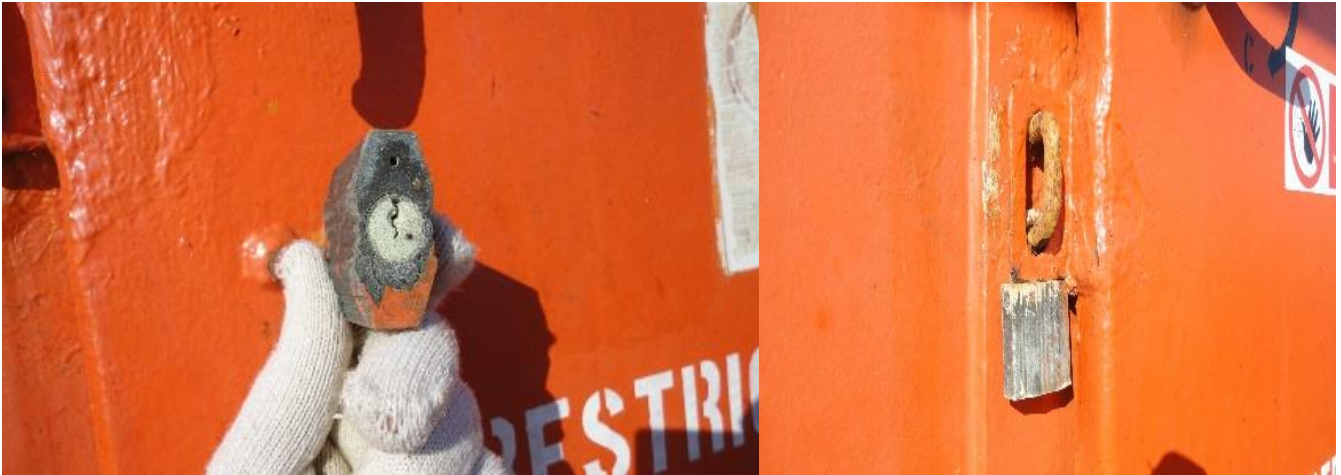
**MRA FINDING:** The padlock of the Air Compressor room was found in extremely poor condition and in need of replacement.

Restricted areas in the ship need to be checked ensuring that they are clearly marked and secured at all times from unauthorised entry.

**THE GOOD CONDITION OF SECURITY EQUIPMENT SHOULD BE VERIFIED PRIOR TO ARRIVAL AT PORT IN ORDER TO ENSURE THE SECURITY OF RESTRICTED AREAS**
